# VEHICLE INSPECTION REPORT

**BN14WTP**

## Iveco Eurocargo 75E16

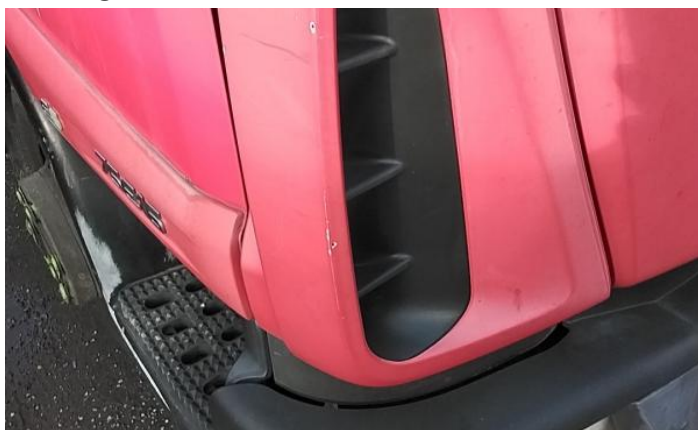
1: Panel Front  
Scratched  
Over 25mm Thru Paint

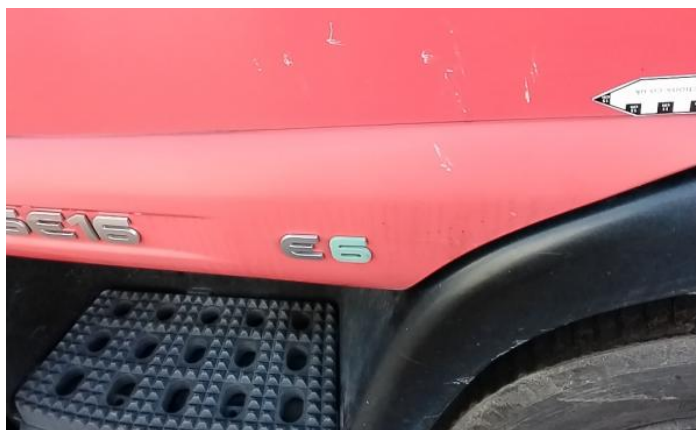
2: Door nsf  
Scratched  
Over 25mm Thru Paint

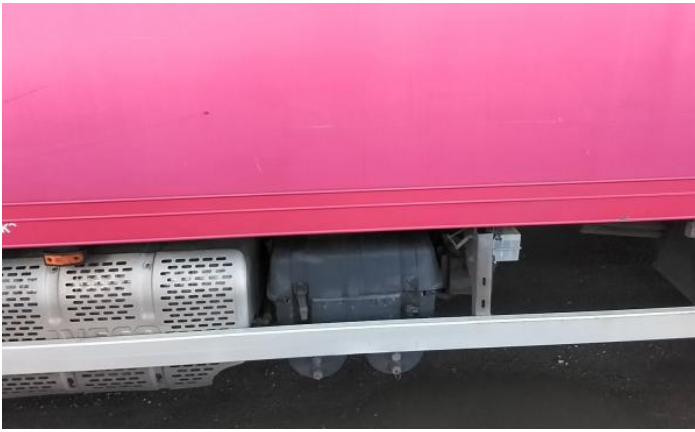
3: Qtr Panel nsr  
Scratched  
Over 25mm Thru Paint

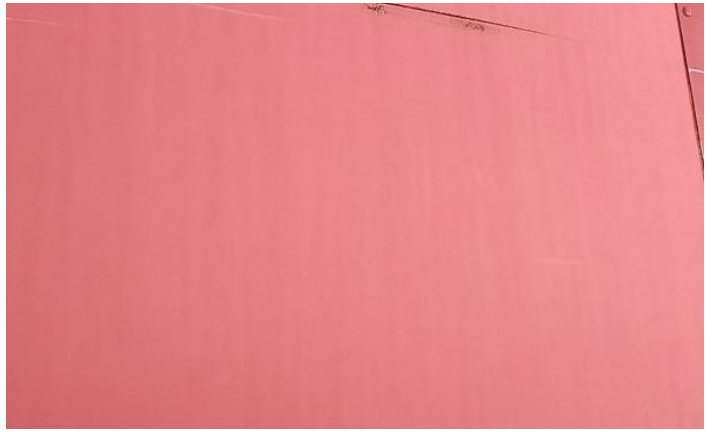
4: Qtr Panel nsr  
Scratched  
Over 25mm Thru Paint

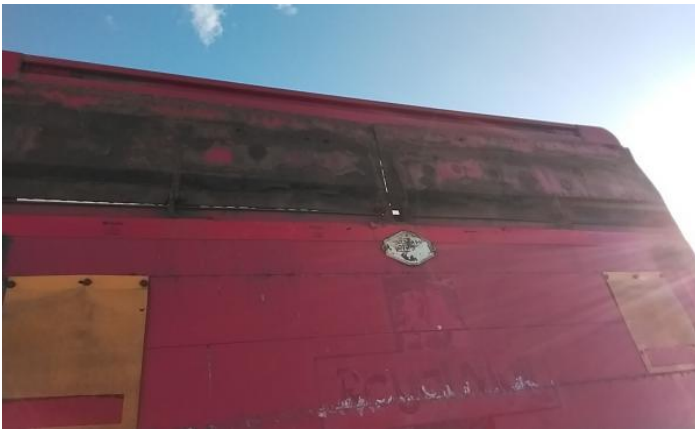
5: Tailgate  
Rusted  
Holed

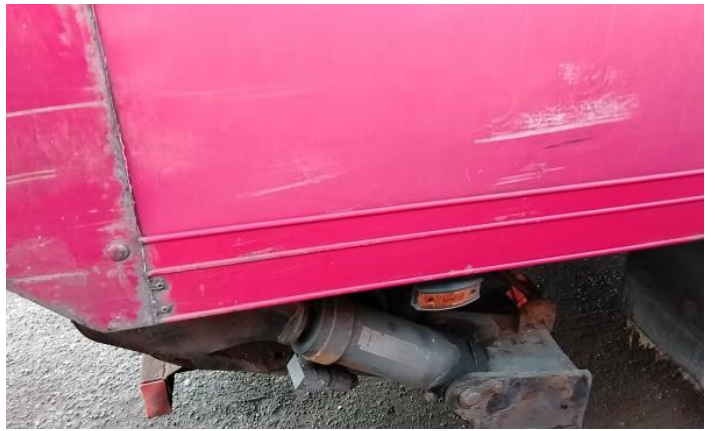
6: Qtr Panel osr  
Scratched  
Over 25mm Thru Paint

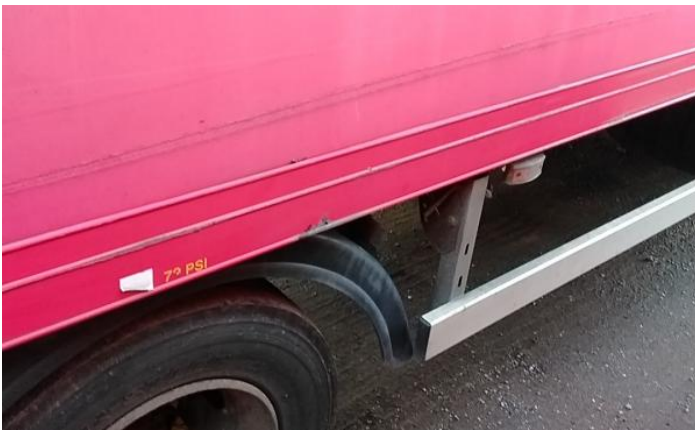
7: Qtr Panel osr  
Scratched  
Over 25mm Thru Paint

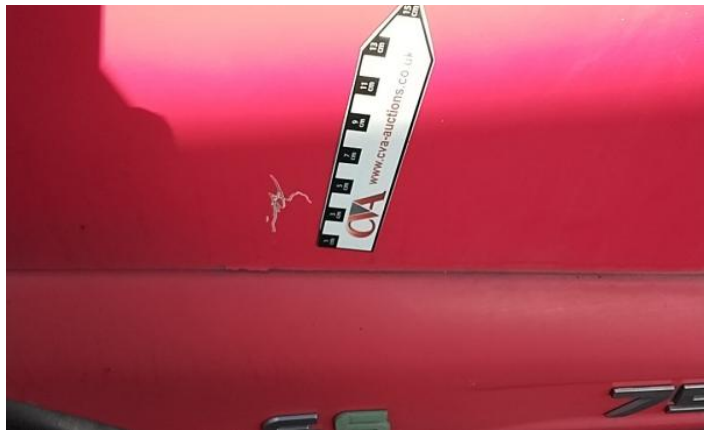
8: Door osf  
Scratched  
Over 25mm Thru Paint

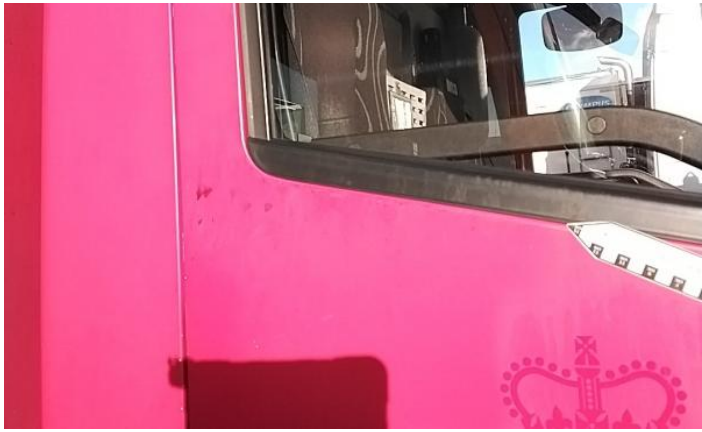
9: Door osf  
Scratched  
Over 25mm Thru Paint
